**Tobyhanna Army Depot
Tobyhanna, PA
11 Hap Arnold Boulevard
Tobyhanna, PA 18466**

**Addendum to Third Five-Year-Review Report
Tobyhanna Army Depot, June 2013**

The Third Five-Year Review Report for Operable Unit (OU) 1, OU-4 and OU-5 at Tobyhanna Army Depot (TYAD) in Tobyhanna, PA was signed by Nathaniel Edwards, Chief, Environmental Management Division and Joseph Maciejewski, Director of Industrial Risk Management in September 12. TYAD received a concurrence letter for the Third Five-Year Review Report from the Environmental Protection Agency (EPA) signed by Ronald J. Borsellino, Director, Hazardous Site Cleanup Division on 25 September 12. In the concurrence letter, the EPA stated that the remedy for OU-1 is protective in the short term and that further action was required to be protective in the long term. EPA's protectiveness statement for OU-1 is as follows:

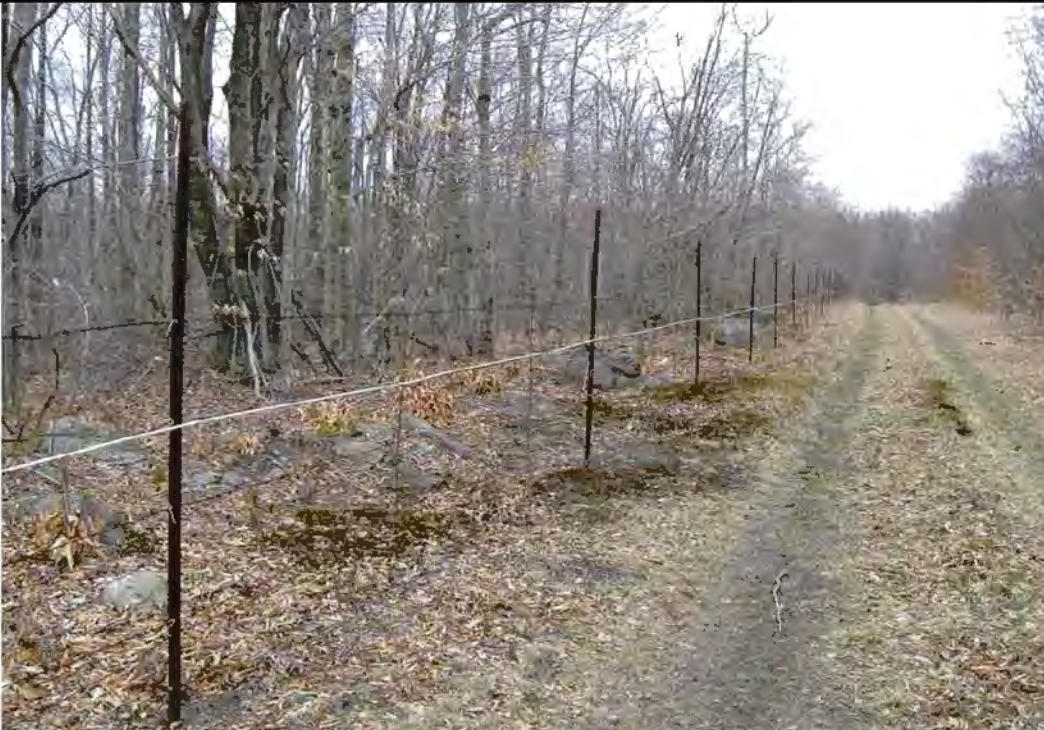
| PHOTOGRAPH: _0081 | |

| COMMENTS: Photos taken for site inspection. Photo showing the condition of the Northern OU-4 UXO boundary fence. | |
